## Event Learning Report

Event Type	People and Safety
Event Title	Blasting Incident
Location	Pole 199360 (P168) Elderslie Road Broadmarsh
Date	11 January 2021
Time	1445 Hours
Risk Rating: Actual	Minor
Risk Rating: Potential	Major
Incident Number	12643

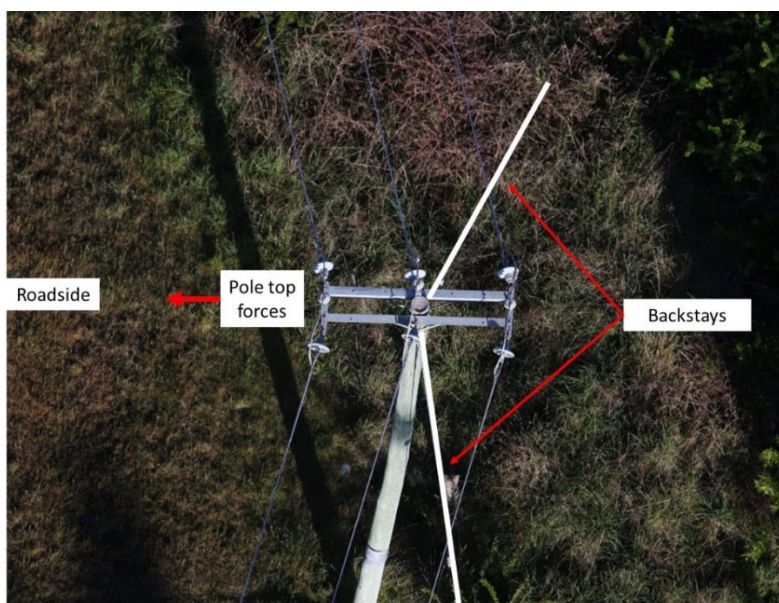
The blast disturbed or weakened the foundation on the roadside of pole 199360. The compromised foundation, coupled with the angle of the pole top forces, pulled the pole towards the road.

**Photo 1: Aerial view of pole 199360 illustrating pole top forces (photo 2014)**

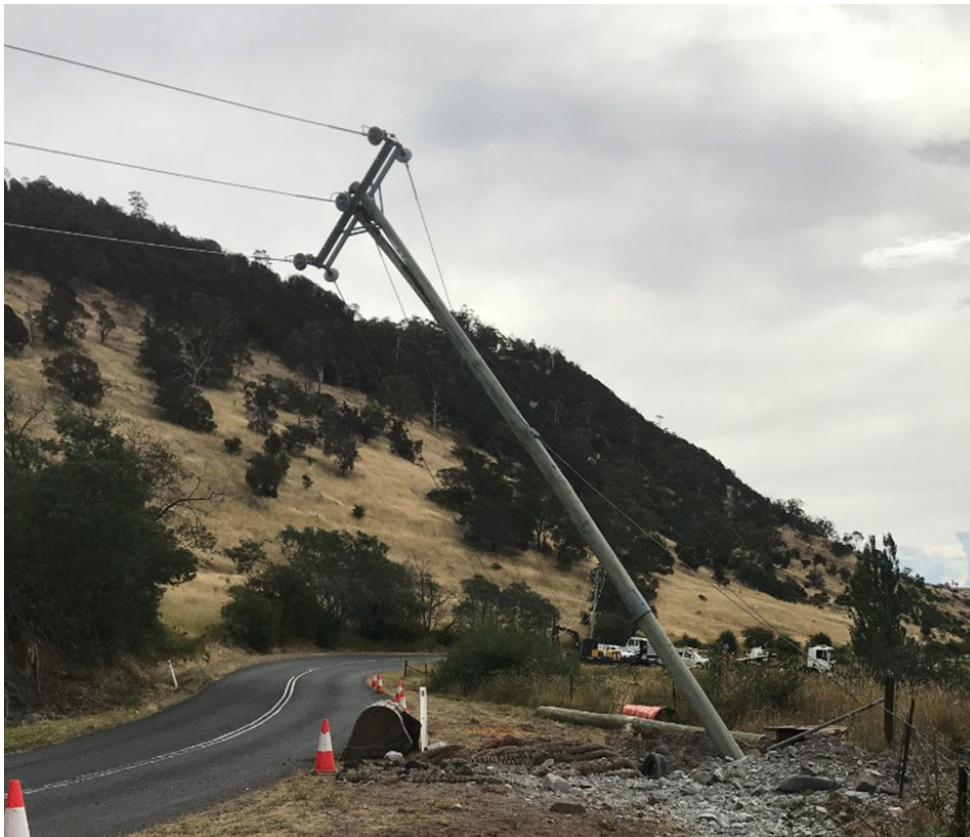
The pole had two backstays and the stay bolts were in line with the split in the pole top. As the pole fell towards the road, the stay bolts pulled downwards, further opening the split until the pole eventually came to a rest at angle of approximately 60° from vertical.

**Photo 2: Pole 199360 post blast, held up by backstays**

The stays remained attached to the pole, which ultimately prevented the pole from falling to the ground.

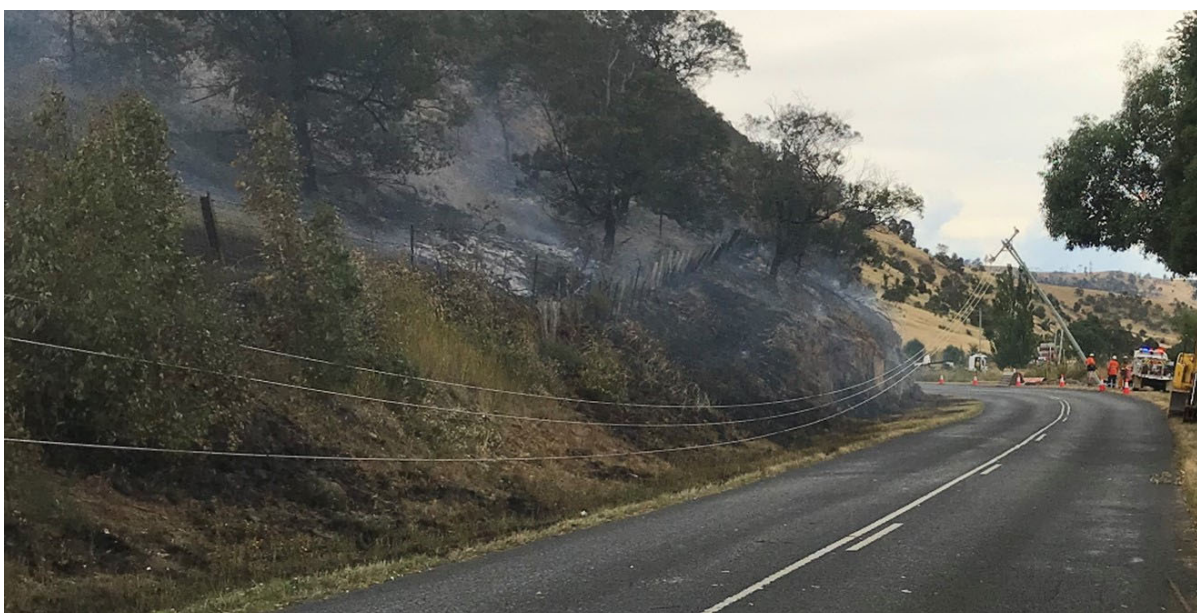
The energised 11kV conductors contacted vegetation, midspan between poles 199359 and 199360, creating a phase to earth short-circuit. The resulting arc flash ignited a vegetation fire.

**Photo 3: HV conductors touching vegetation between poles 199359–199360**

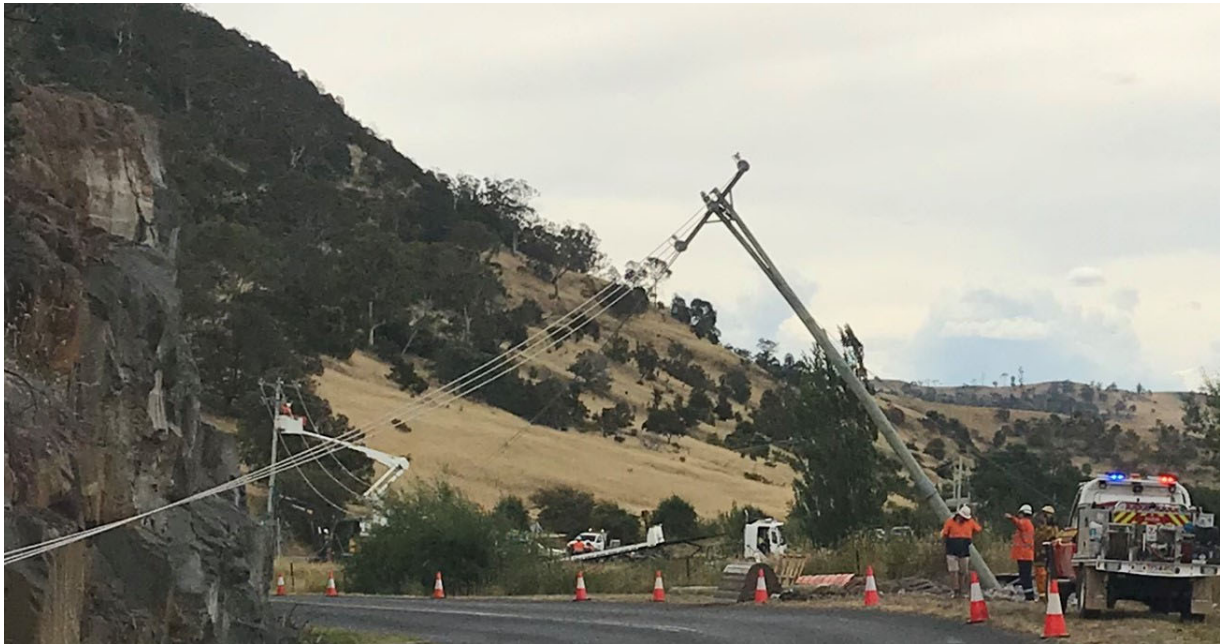
1. The pole was an angled pole, which had a split in the top of it and it was structurally compromised (which was why it was being replaced).
2. The amount of explosives used created too much pole vibration and weakened the foundation between the pole and blast hole.
3. The distance between the pole and blast hole was 400mm.

**Photo 4: Illustrates split in pole top**

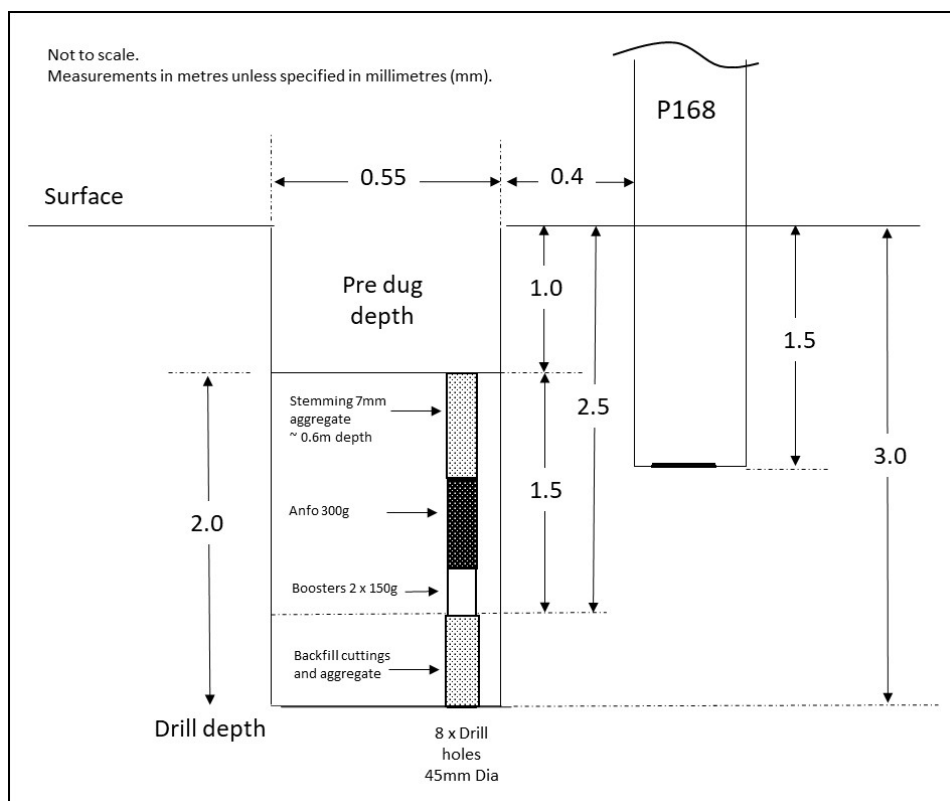
**Diagram 1: Cross-sectional view of site**

- The calculated powder factor was 3.9. A powder factor is the quantity of explosives used per cubic metre of rock. The powder factor is based on the methodology that a set number of kilograms of explosives per cubic metre of rock will give a specific desired blast result.

13. The location for the new pole hole was pegged 400mm off the existing pole by TasNetworks. The civil contractor reports that they always aim to dig holes where TasNetworks request it to be placed. They reportedly understand from past experience that by moving the hole to another nearby location, it can have knock on effects to the design of the network along with additional costs for materials and work load if the hole is moved too far from its pegged location.

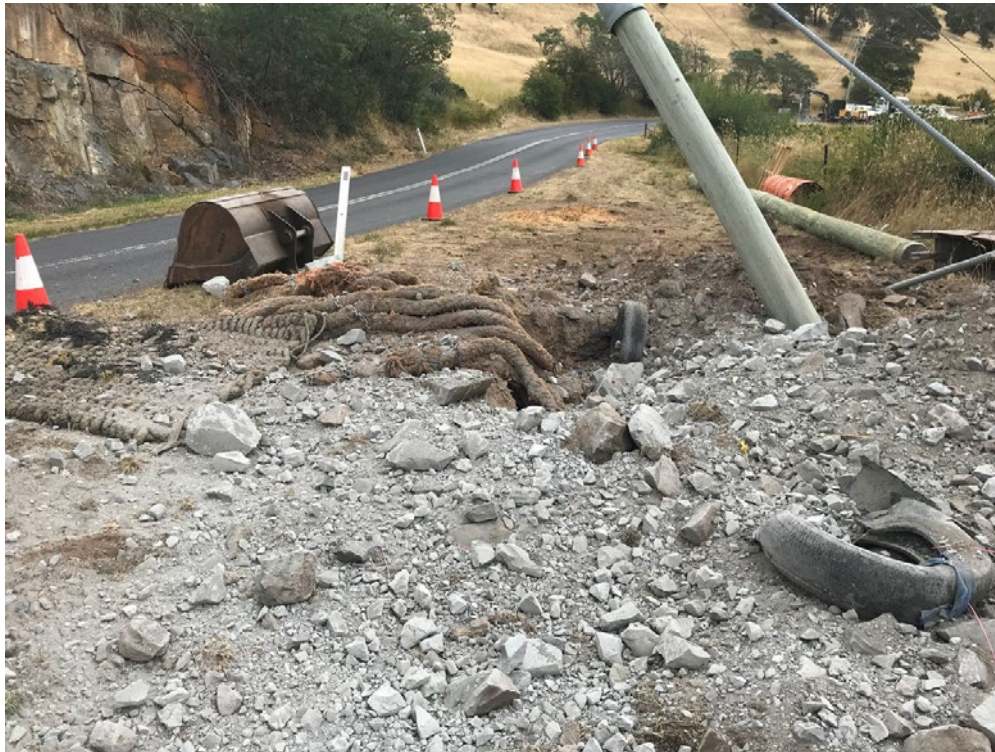
It is observed from photo 5 that the mud bucket (350kg in weight) has been thrown about three metres towards the road from where it was originally placed against the pole.

It is also observed that the blast was not contained.

**Photo 5: Scene immediately after blasting**

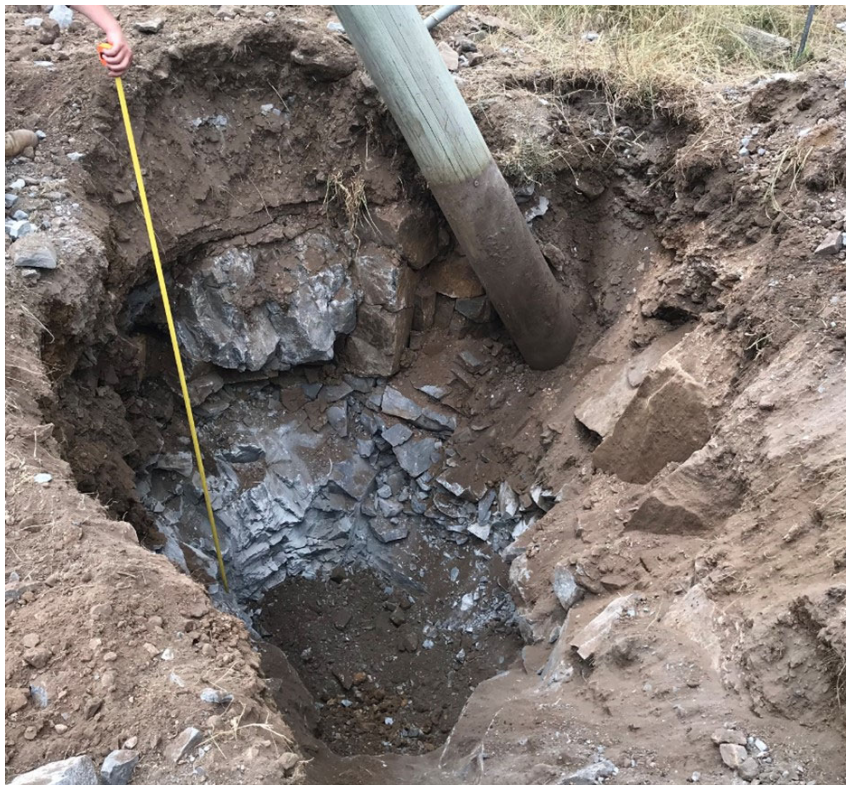
8. The blast fractured the ground between the new hole and the existing pole.

**Photo 6: Shows pole foundation compromised between pole and new pole hole (after dig out)**

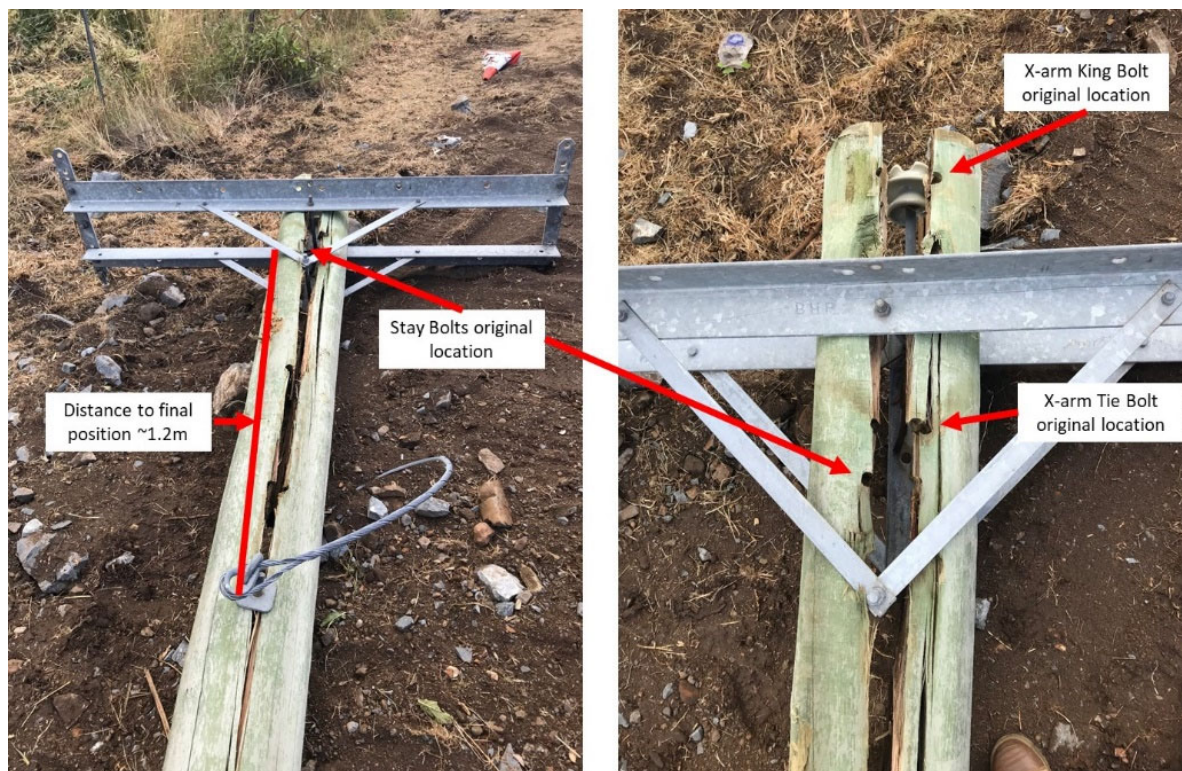
9. Evidence indicates the base of the pole has been lifted upwards and rattled hard during the shock of the blast. This has caused the stay bolts, which were in line with the split in the pole top, to pull downwards through the pole, further opening the split as the pole fell towards the road due to the compromised foundation.

**Photo 8: Pole 199360 – post blast after recovery**

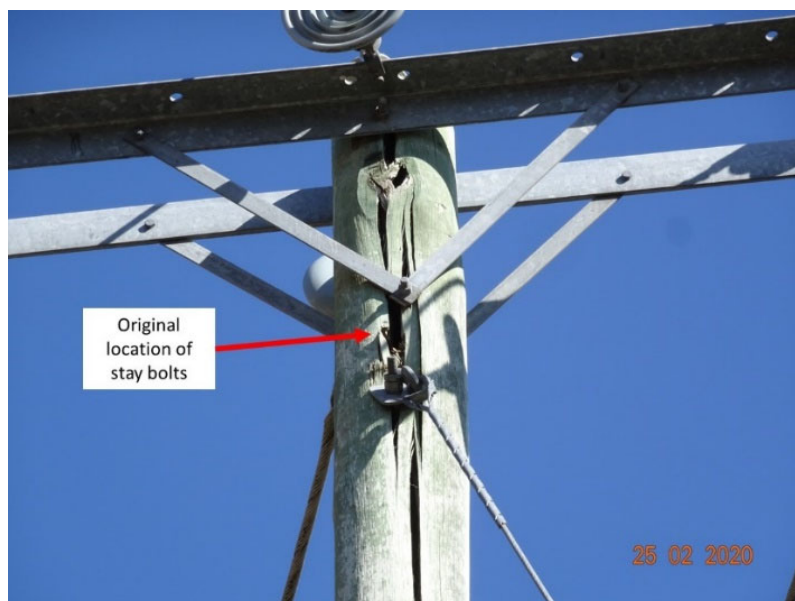
1. Pole 199360 is a fully supported HV strain pole, which was installed in 1988. The pole was inspected on a five yearly cycle.
2. On 25 February 2020, the pole was inspected by an Asset Officer and a crack was identified in the pole top. The pole had a safety factor of 4.5, which is considered sound and not affected by wood rot.
3. The Asset Officer condemned the pole and assigned a replacement priority of P6, which required the pole to be replaced with 365 days.

**Photo 7: Illustrates crack in pole (taken 25/02/2020)**
